Site Name: <u>Progress Energy Asheville</u>	Date: <u>29 MAY 2009</u>
Unit Name: <u>1964 POND</u>	Operator's Name: <u>PROGRESS ENERGY</u>
Unit I.D.:	Hazard Potential Classification: <u>High</u> Significant Low
Inspector's Name: <u>FREDERIC SHMURAK / JUSTIN STORY</u>

Site Name: Progress Energy Asteville Date: 29 May 2009
 Unit Name: 1982 Pond Operator's Name: PROGRESS ENERGY
 Unit I.D.: _____ Hazard Potential Classification: High Significant Low
 Inspector's Name: Frederic Shmurak / JUSTIN STORY

PHOTOGRAPH LOCATION PLAN
ASH PONDS - PROGRESS ENERGY
ASHEVILLE STEAM ELECTRIC PLANT
SKYLAND, NORTH CAROLINA

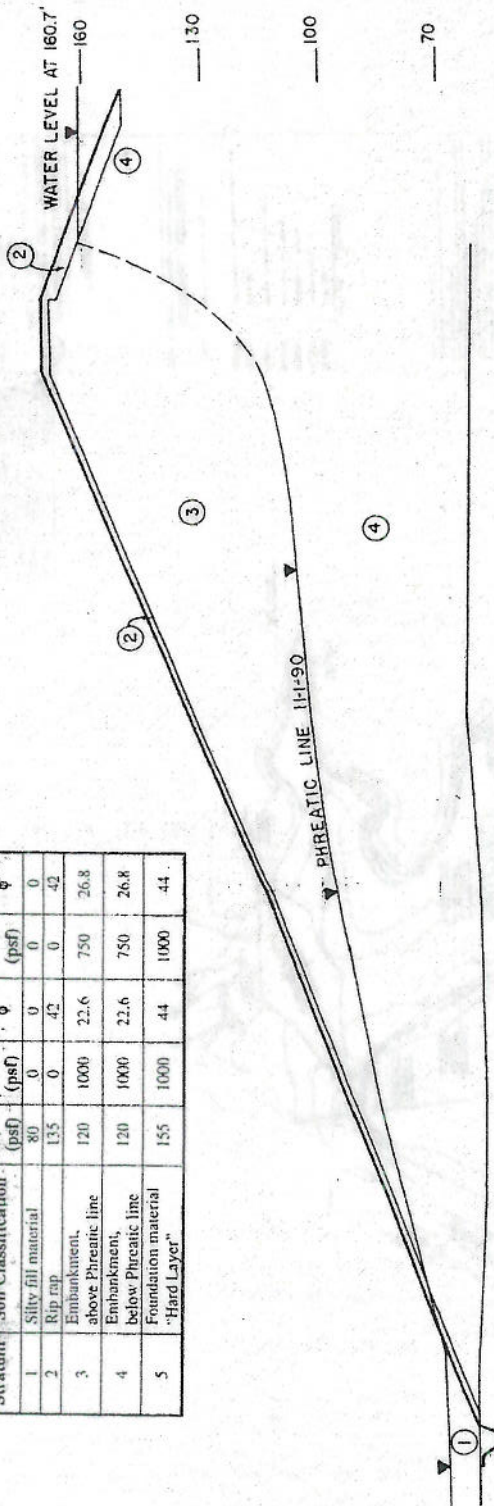
Stability Analyses Summary - Downstream Slope			
Condition	Calculated safety Factor	Safety Factor Criterion	
Static Loading: • Normal Reservoir @ elevation 2160.7 ft. - steady state seepage	1.76	1.50	
• Flood with Reservoir @ elevation 2170 ft.	1.75	1.30	
Seismic Loading: • Normal Reservoir @ elevation 2160.7 ft. - steady state seepage	1.20	1.0

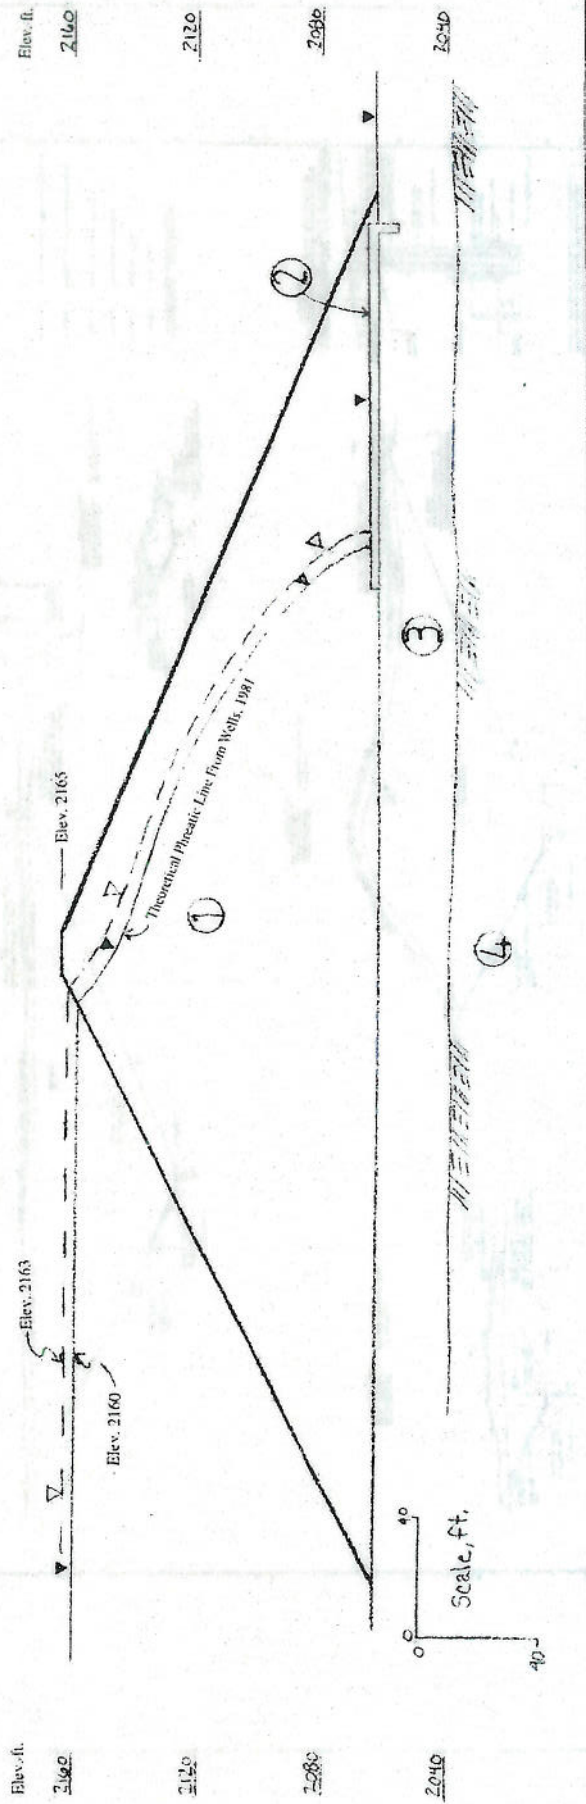
STABILITY MODEL - DOWNSTREAM SLOPE - 1982 ASH POND DAM
PROGRESS ENERGY
ASHEVILLE STEAM ELECTRIC PLANT
SKYLAND, NORTH CAROLINA

Stability Analyses Summary - Downstream Slope			
Condition	Calculated safety Factor	Safety Factor Criterion	
Static Loading:			
• Reservoir @ elevation 2160 ft-steady state seepage	1.68		1.50
• Reservoir @ elevation 2163 ft-steady state seepage	1.63		1.50
Seismic Loading:			
• Reservoir @ elevation 2160 ft-steady state seepage	1.07		1.0
• Reservoir @ elevation 2163 ft-steady state seepage	1.03		1.0

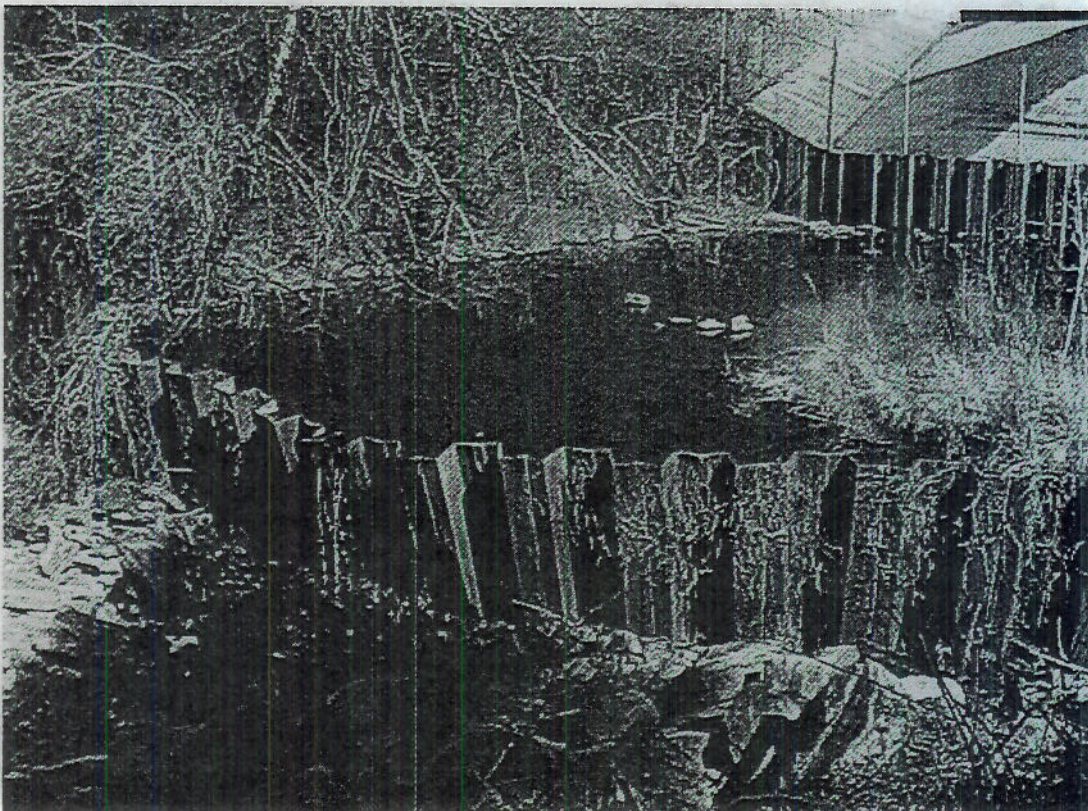
The stilling pools are also in good condition. The first stilling pool has scattered rip-rap along the bottom and is in about the same condition as reported in the 2002 inspection report. The displaced sheet piles creating this pool appear not to have changed, judging from previous reports (photographs 11 and 12). The second pool located downstream from the first also appears to be in generally good condition.

Photograph 11: Cooling Lake Dam – spillway drop walls and energy dissipation pool.

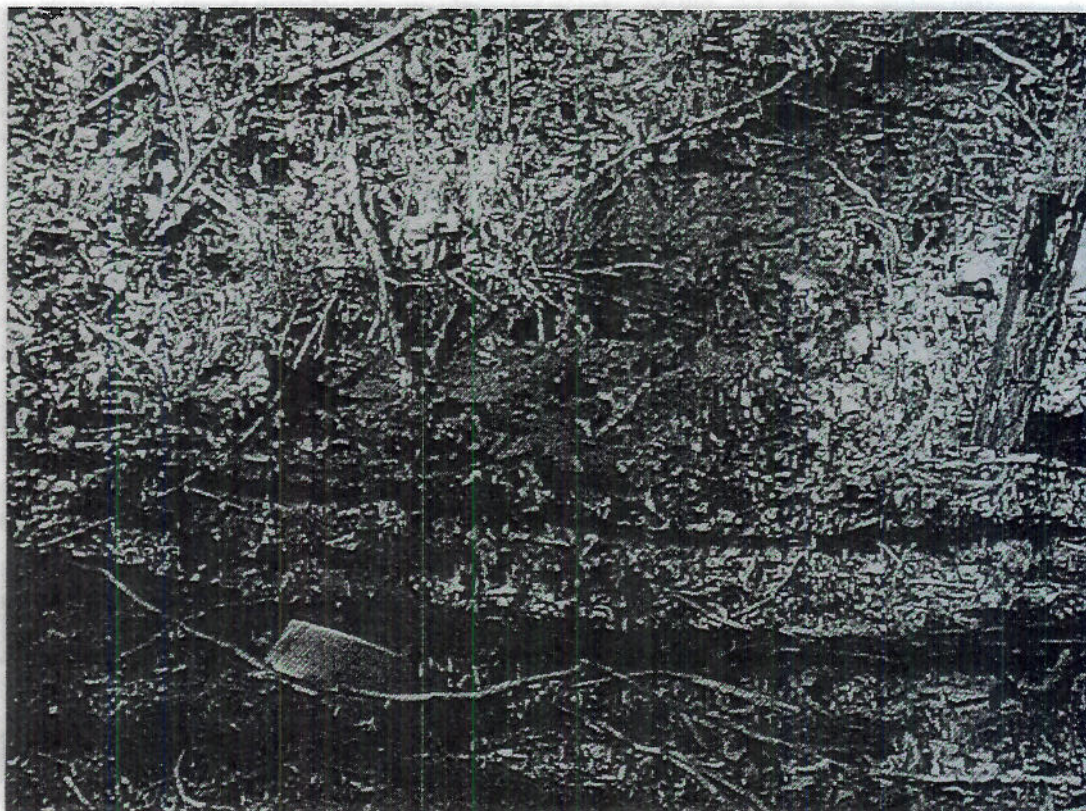
Photograph 23: 1964 Ash Pond – concrete patch at soil/concrete flume interface.

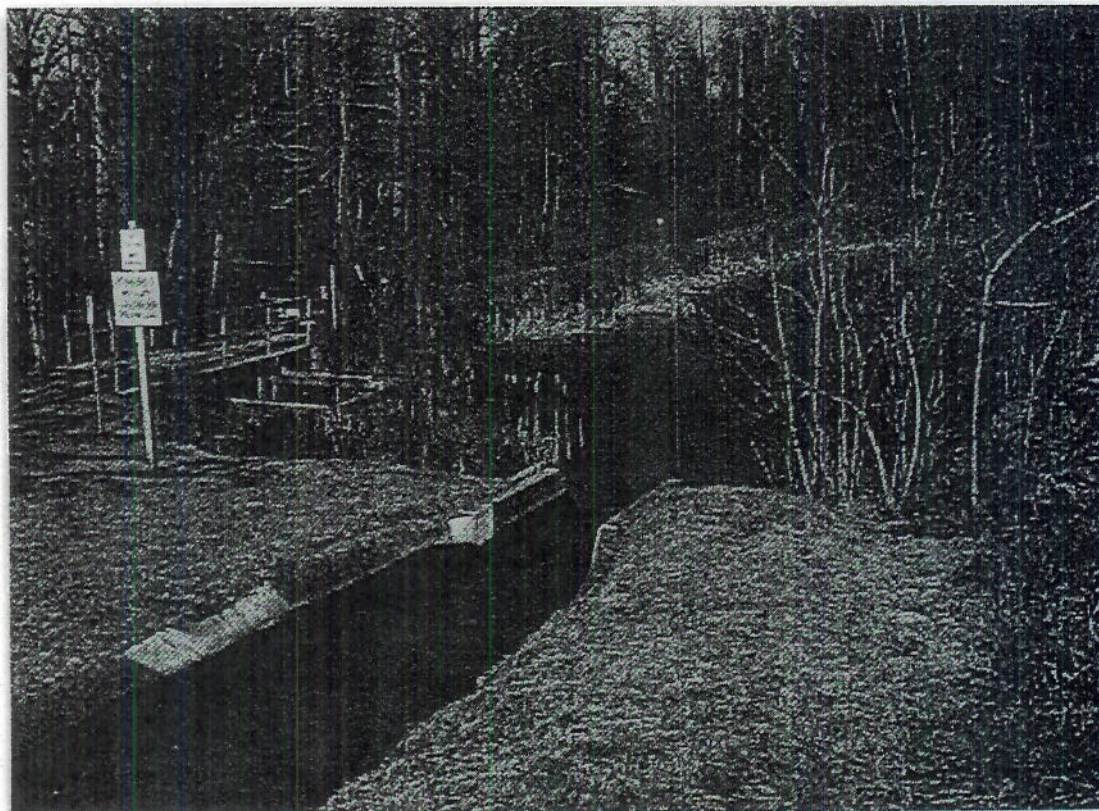
The skimmer, stilling basin and outlet structure are in good condition (photographs 25 and 26). No evidence of deteriorating concrete was observed at the outlet structure.

Photograph 25 – 1982 Ash Pond – skimmer at southwest area of pond.

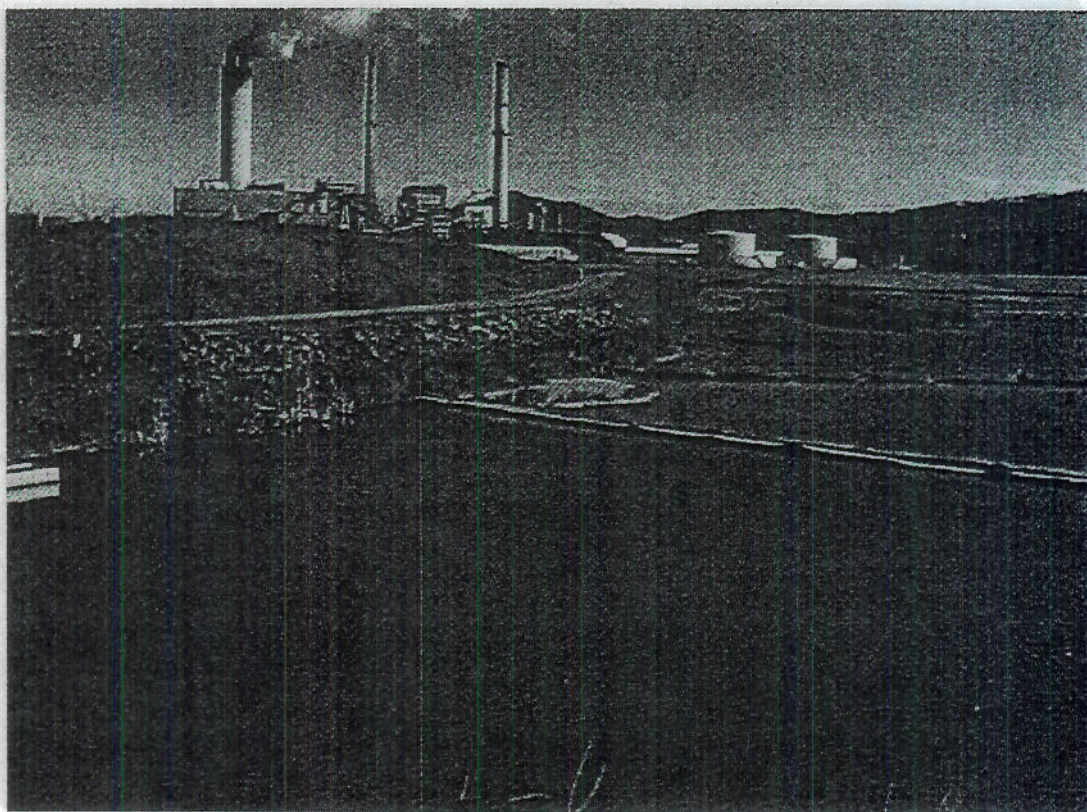
Photograph 26: 1964 Ash Pond – concrete flume discharge into stilling pond.

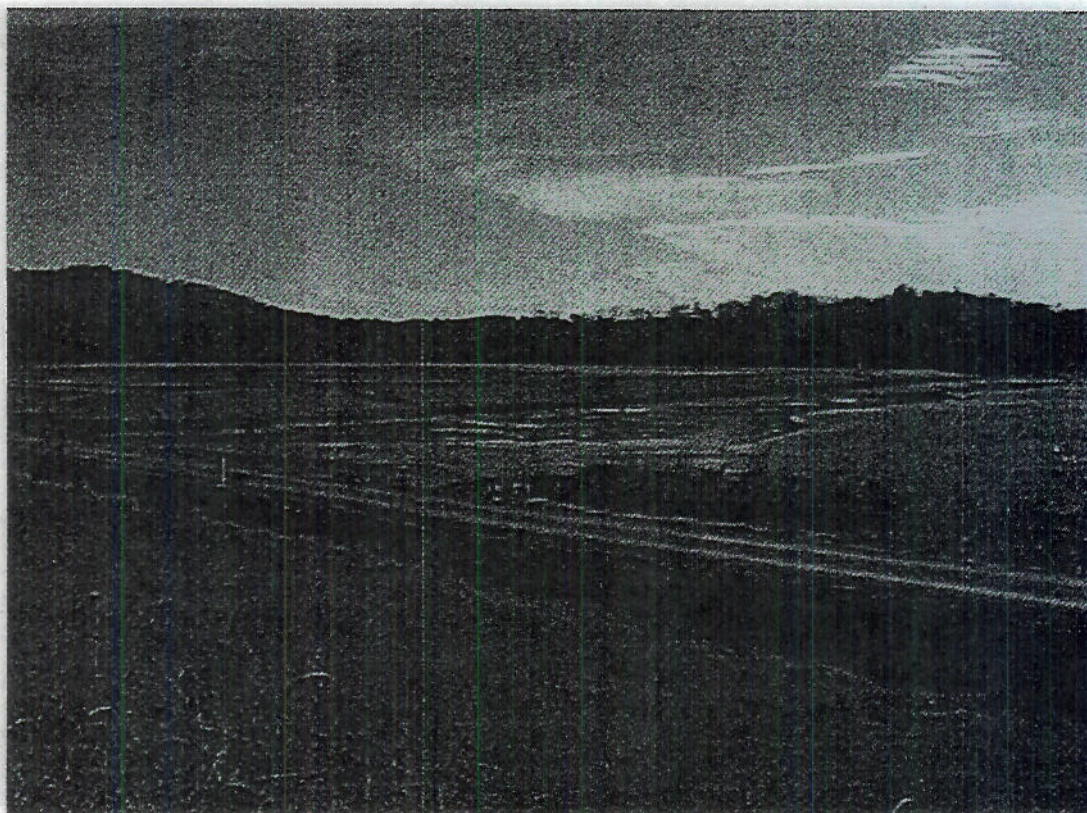
With construction of the 1982 Ash Pond, the southeast portion of the 1964 Ash Pond dam became a separator dike (photograph 27). At the time of the 1987 inspection, the southernmost portion of this dike had experienced a minor slide of the rip-rap into the new ash pond. The linear extent of the slide was about 225 feet and the slide depth appeared to be shallow, not extending into the soil portion of the dike. No significant movements appear to have taken place in this area subsequent to the 1987 inspection. The slope appears to remain in relatively good condition 20 years after the slide. Ash reclaimed from the 1982 pond has been dry stacked within the former 1964 Ash Pond near the separator dike, effectively reducing the height of the separator dike along approximately $\frac{3}{4}$ of the length of the separator dike.

Photograph 27: Dike between 1982 Ash Pond and 1964 Ash Pond, interior slope, looking west.

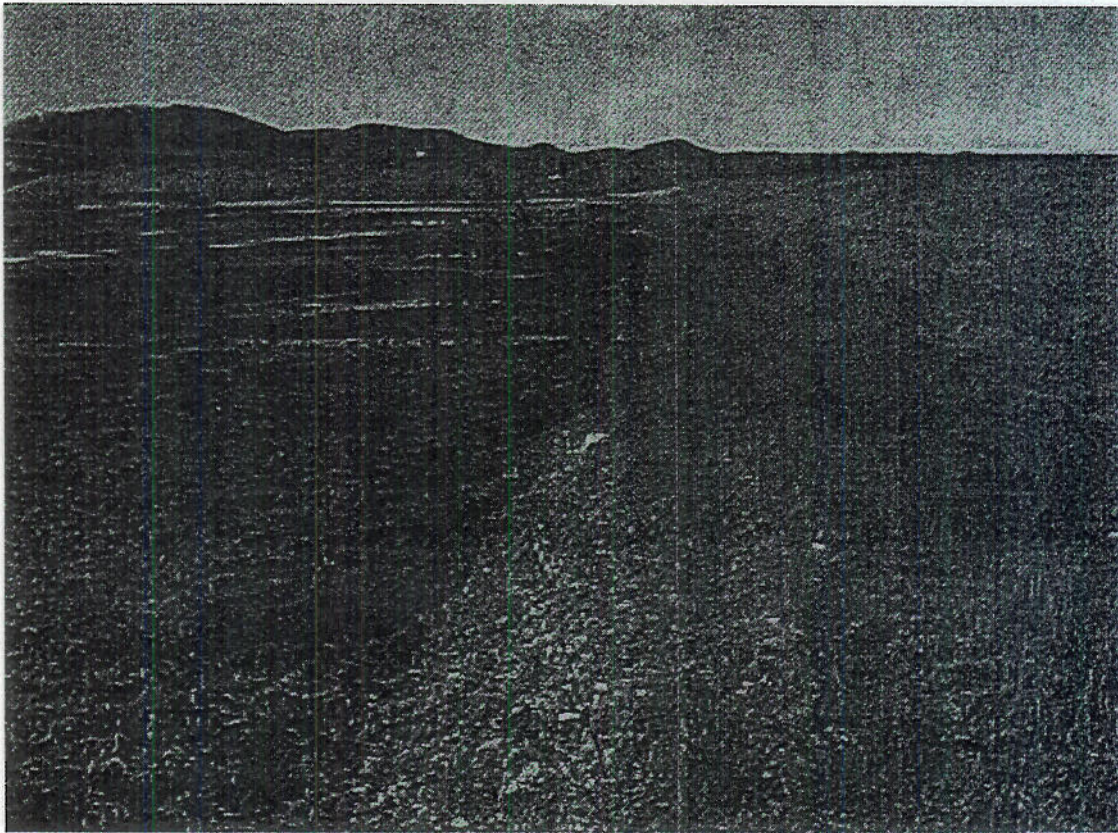
The internal ash dike, located within the northern half of the 1982 Ash Pond (photograph 28), was constructed in 2006 with ash excavated from the 1982 Ash Pond. The internal ash dike was observed to be in overall good condition. Grass cover was observed on the upstream and downstream slopes of the internal ash dike (photograph 29). The outlet pipe located at the southeast corner of the internal dike appears to be in good condition (photograph 30).

Photograph 28: 1982 Ash Pond and internal ash dike within 1982 Ash Pond, looking northeast.

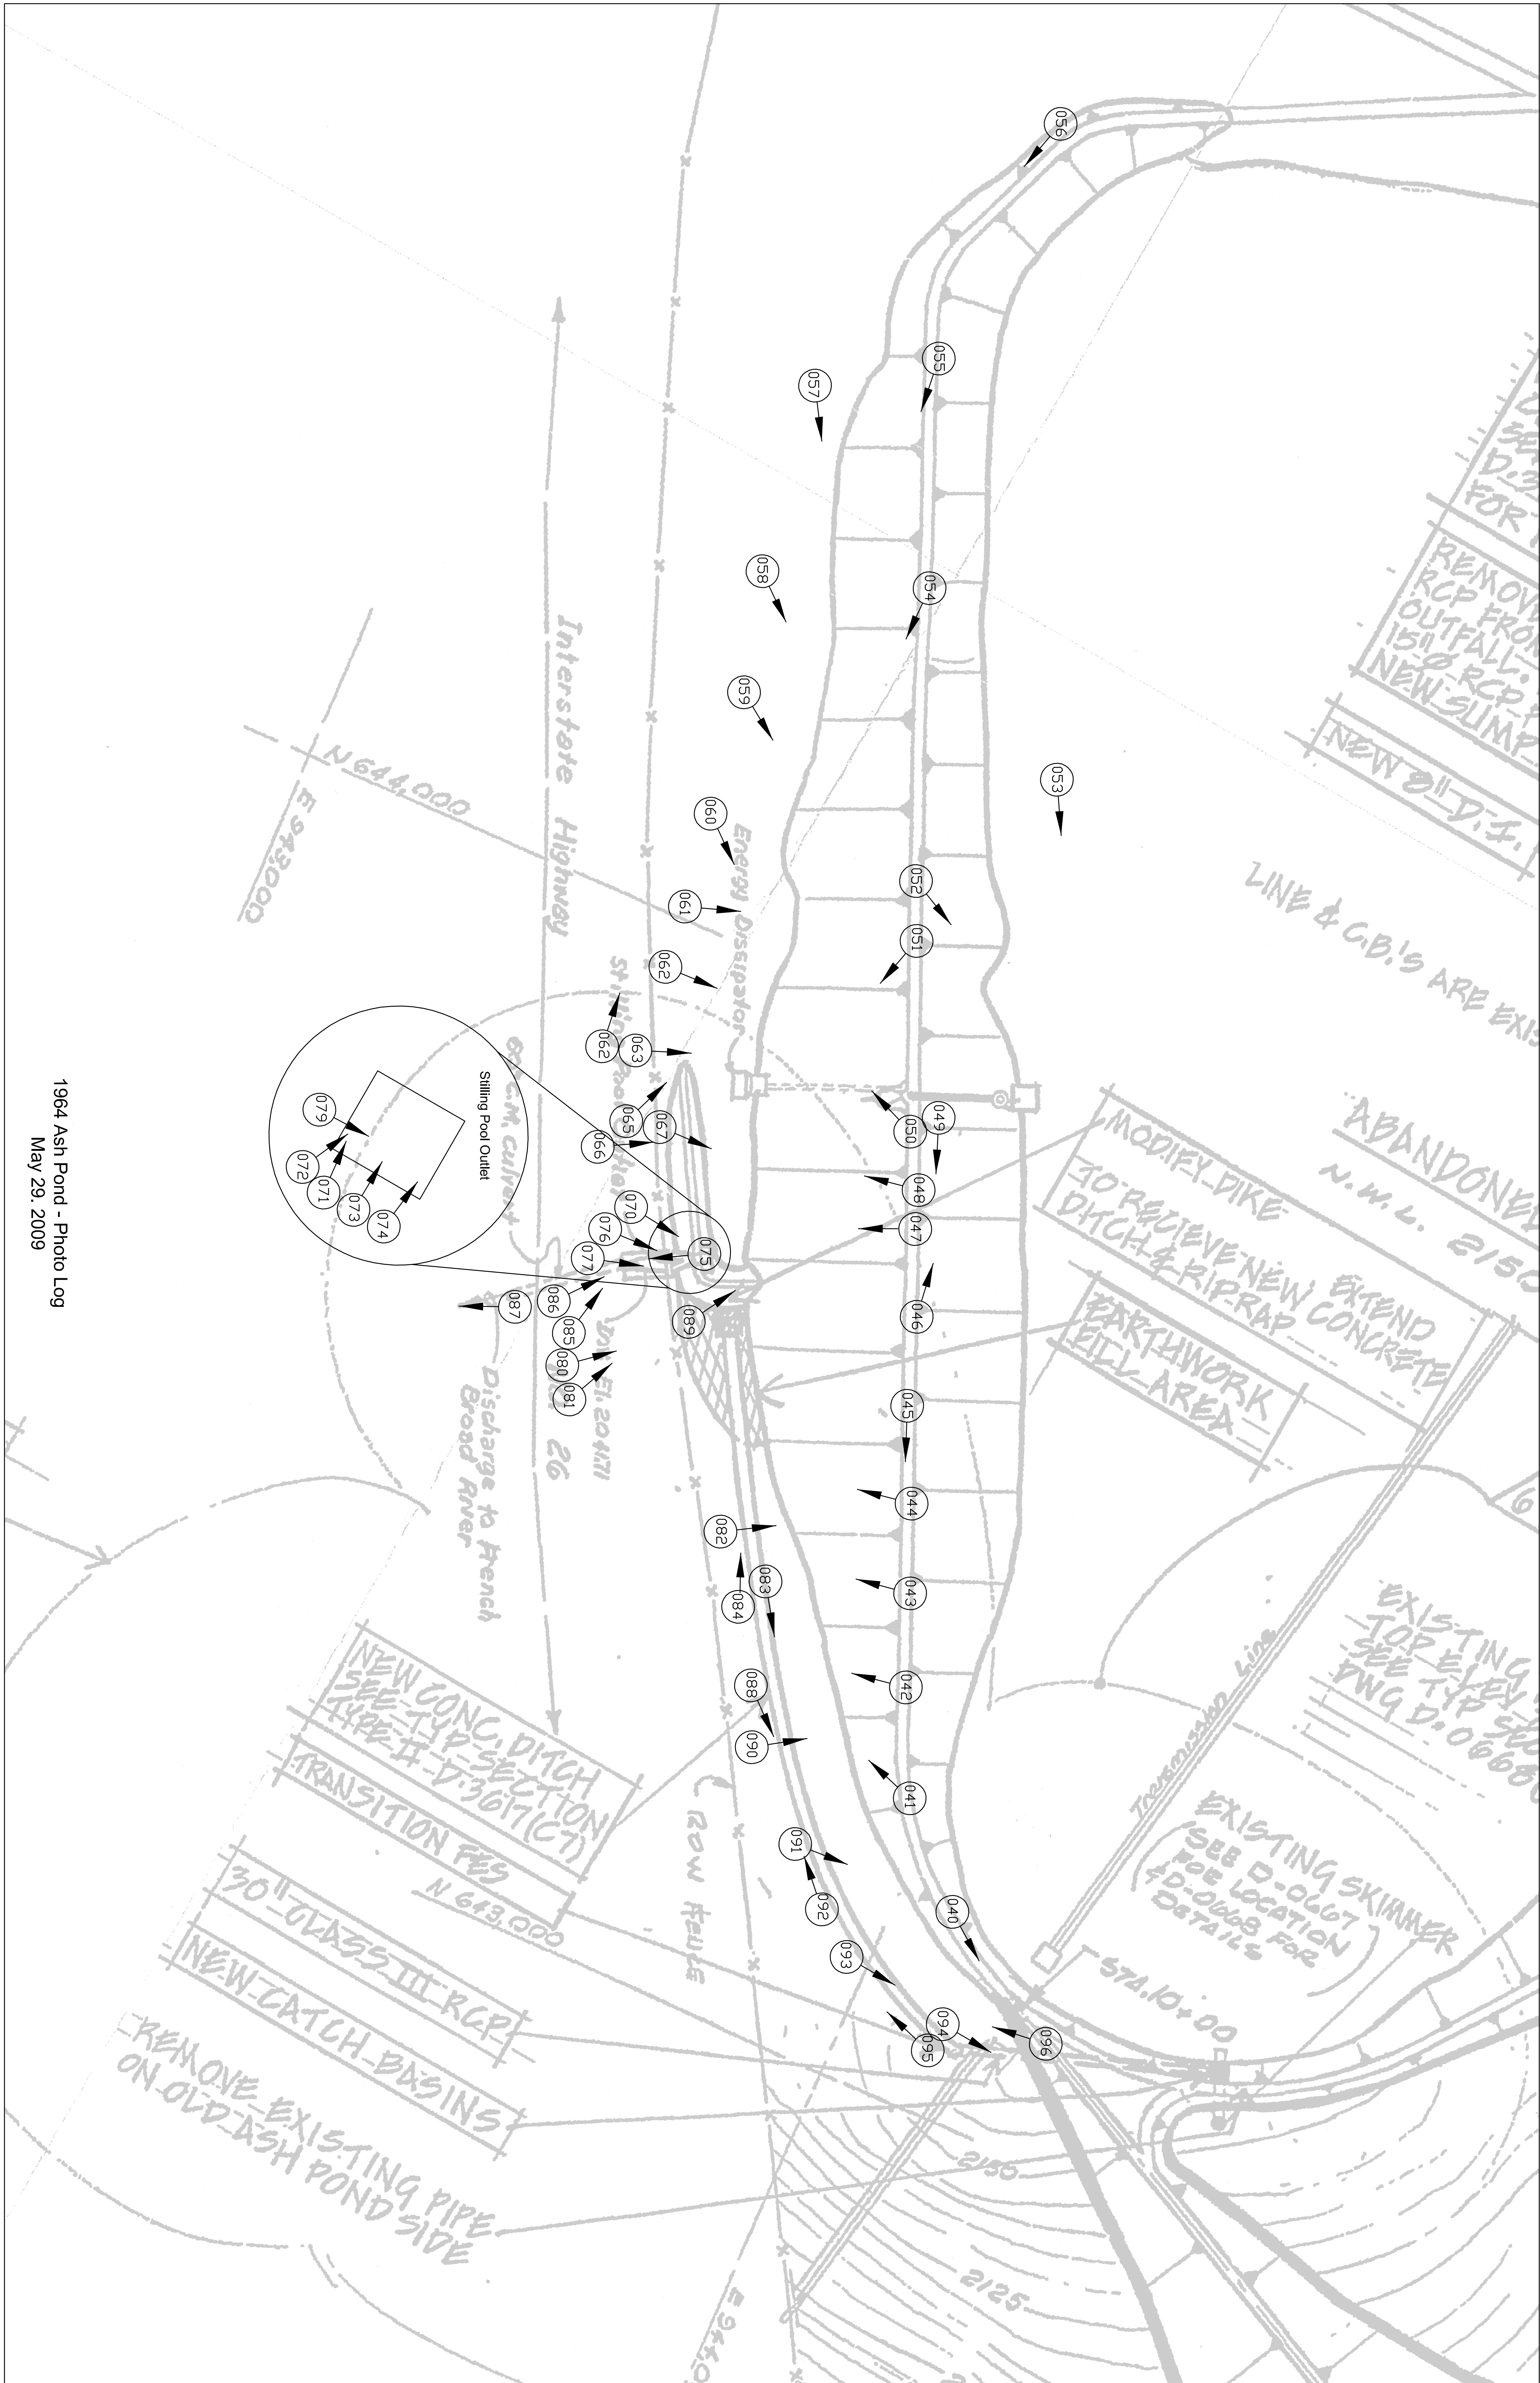
Photograph 30: Internal Ash Dike (within 1982 Ash Pond), outlet pipe at southeast corner of dike.

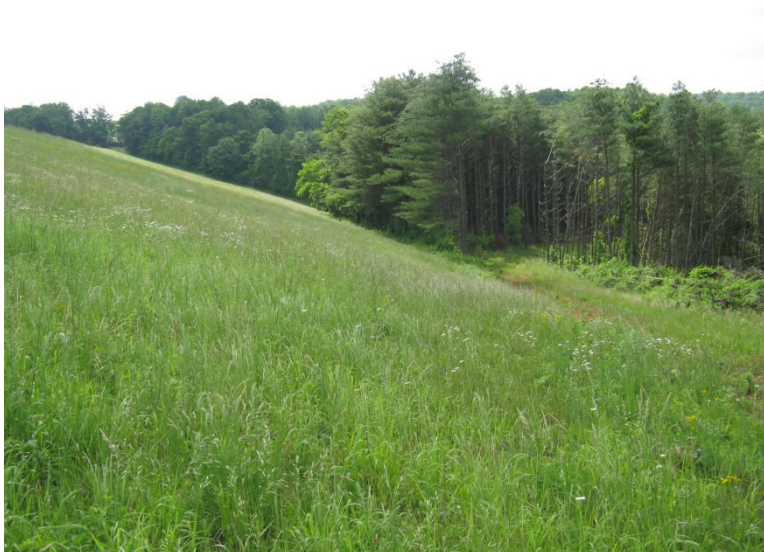
Photo 16: 1982 Dam - View of Right Groin, Right Abutment, Photo: 016, 5/29/09
(note: right and left are based on the observer facing downstream)

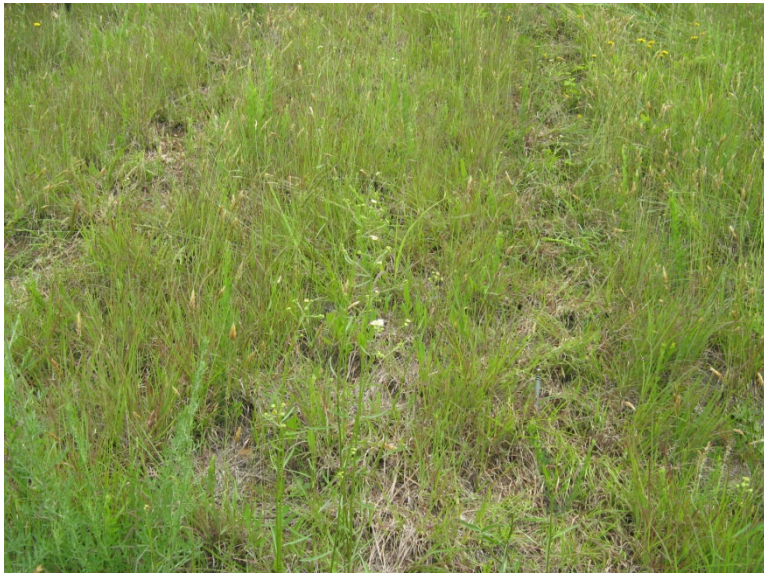
Photo 18: 1982 Dam – Minor Rill Erosion, Downstream Embankment, Photo: 033, 5/29/09
